**PLAN OF CONTROL
PREPARED FOR PROPOSED SANTIAGO GEOLOGIC HAZARD
ABATEMENT DISTRICT
ANAHEIM HILLS, ANAHEIM, CALIFORNIA**

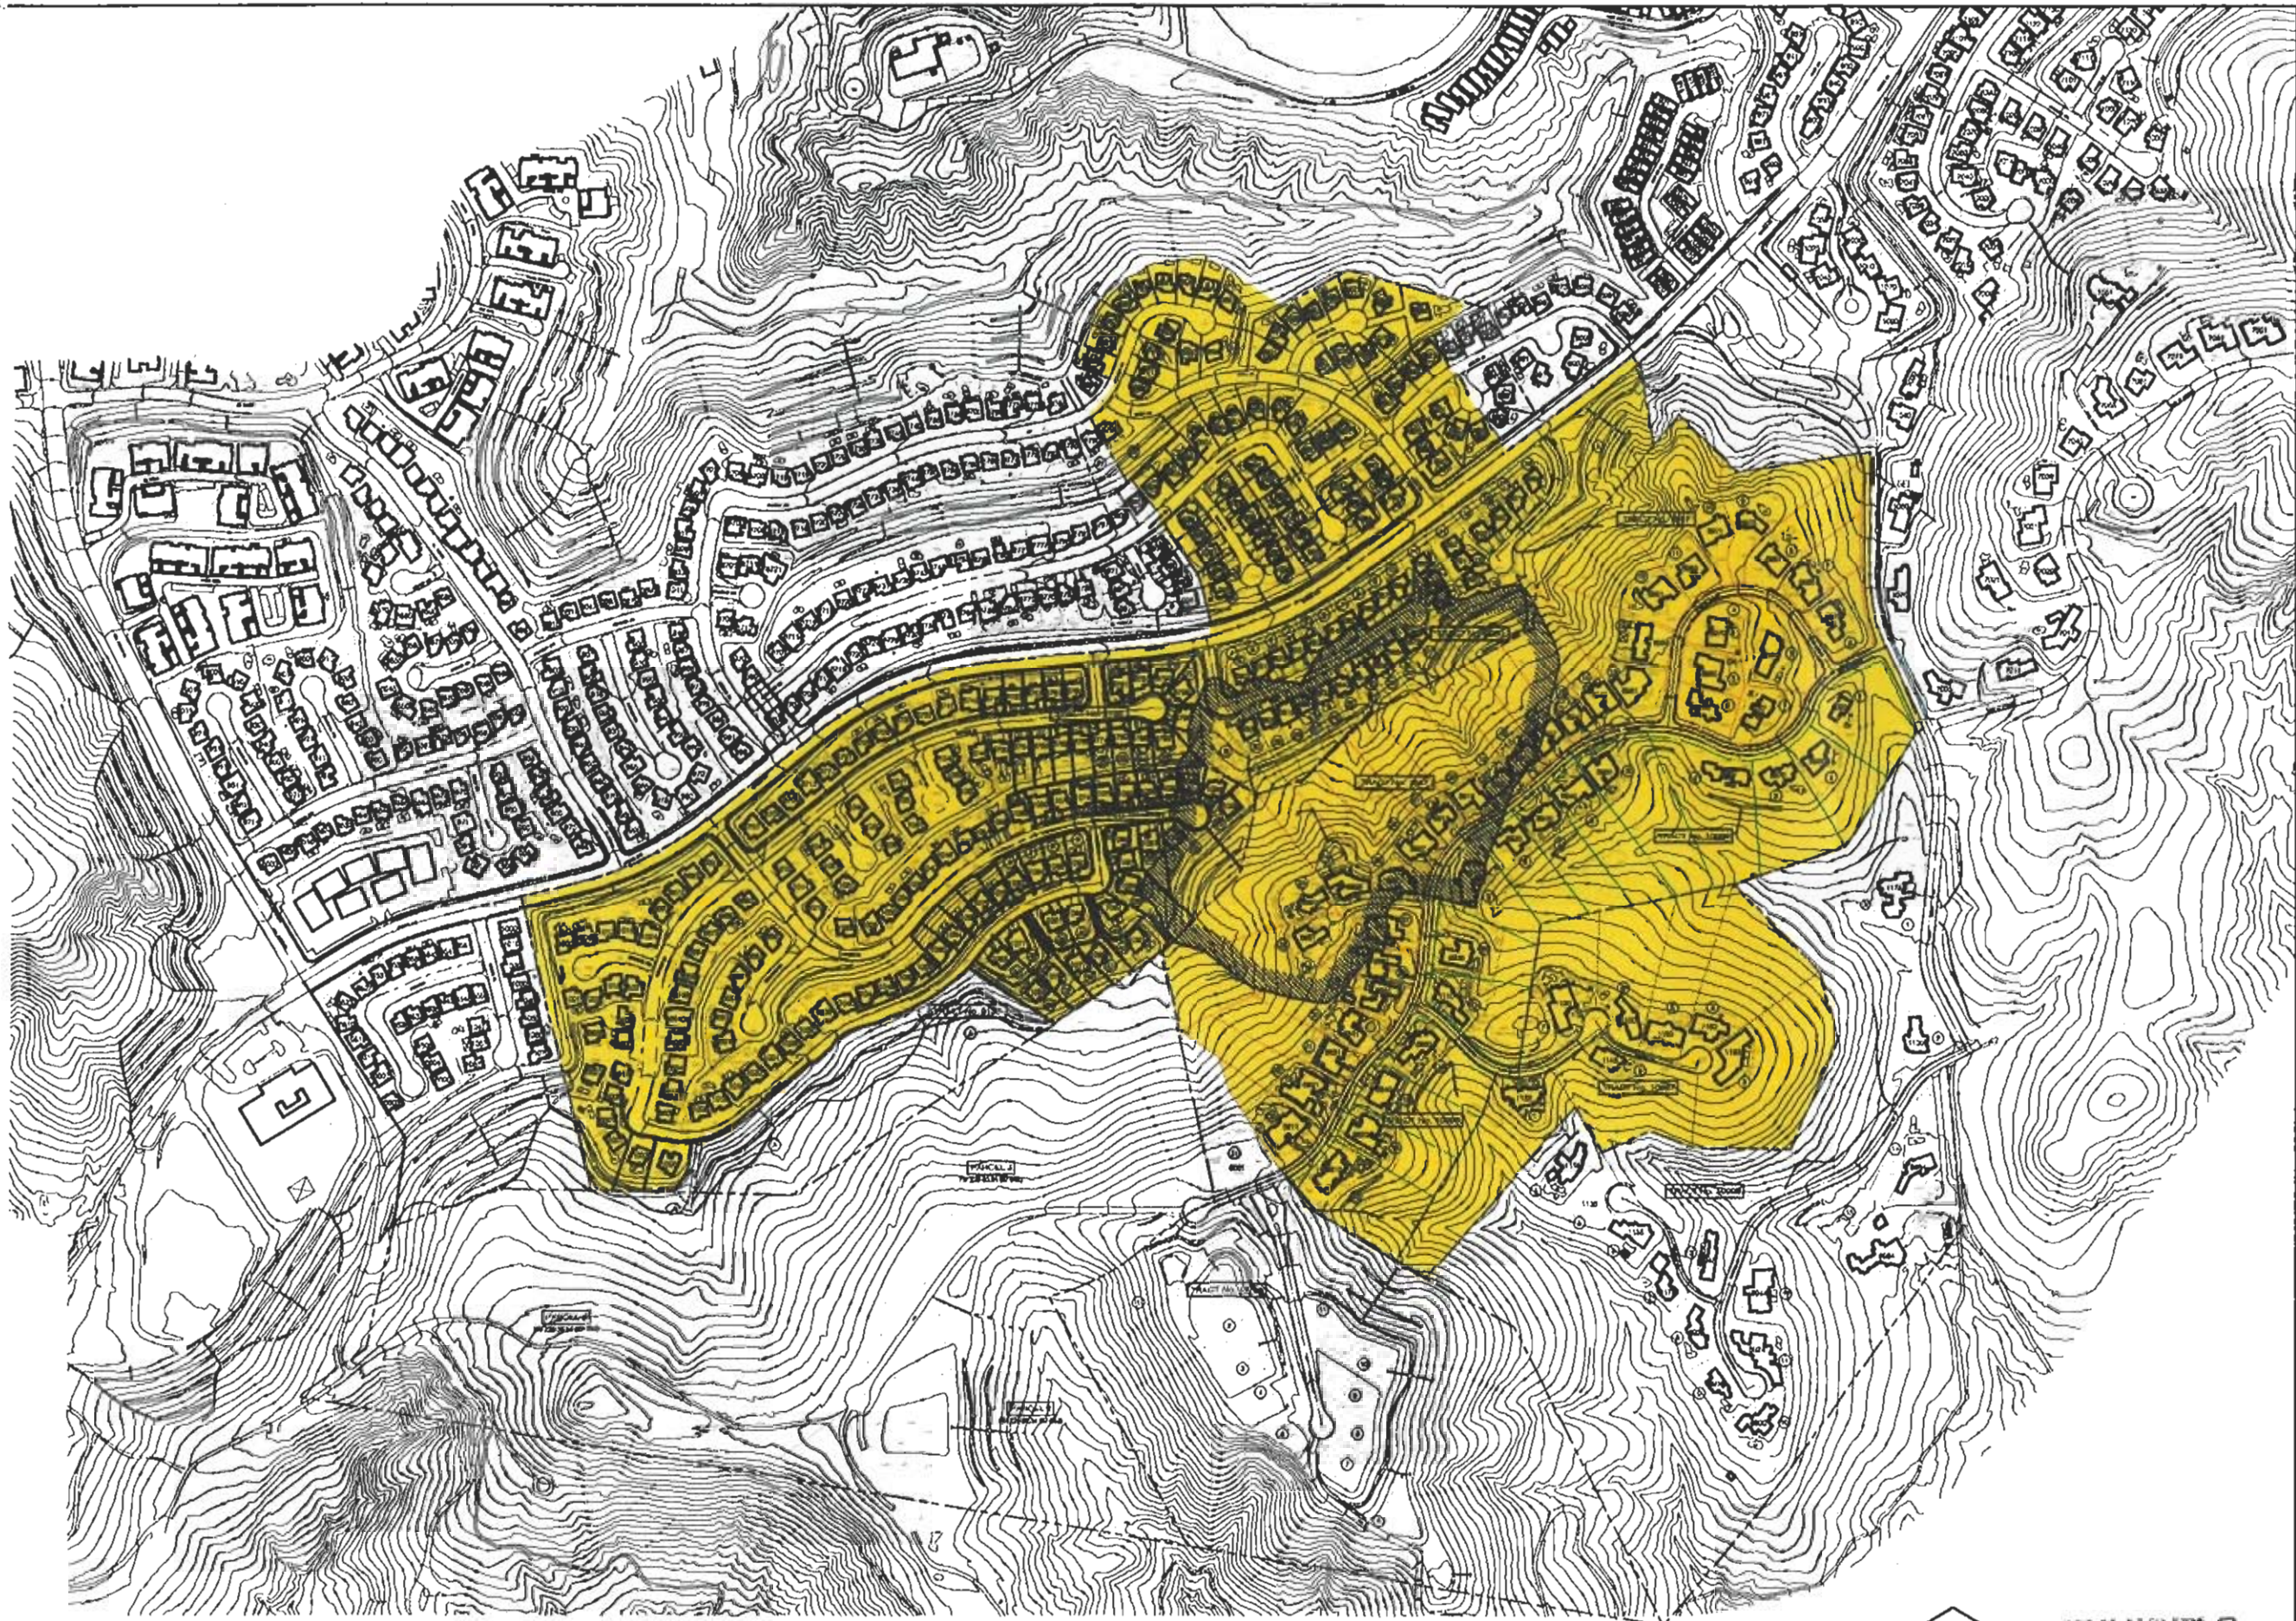
LIMITS OF SURFACE DAMAGE - SANITARIO LANDSLIDE BY EREBRANT AND STONE (DIGITIZED FROM EAS PLATE, DATED FEBRUARY 15, 1981)

GEOLOGIC HAZARD MITIGATION DISTRICT BENEFIT AREA

landslide mass detached along weak, north-dipping stratification, facilitated by an adversely oriented (for area stability) fault which allowed translational movement at the toe (down-slope) limit of landsliding. These geologic factors are discussed in depth by the E&S report and illustrated on geologic maps and cross sections appended thereto. A precise limit or boundary for the landslide mass was defined by a continuous series of cracks and other contemporaneous damages, as portrayed on the reference Plate H.1 of the E&S report. The limit of Santiago Landslide surface distress is plotted on the map attached to this Plan of Control.
